ITP 1 Overview

The second ITP that was fielded was ITP1, which was deployed in the Beaufort Sea as part of the Beaufort Gyre Observing System (BGOS) during the JWACS 2005 cruise on the CCGS Louis S. St. Laurent. ITP 1 and a US Army Cold Regions Research and Engineering Laboratory (CRREL) Ice Mass Balance Buoy were deployed on a 4.6 m thick multiyear ice floe in a location designed to drift through the BGOS array over the following year. The profiler unit operated until it exhausted its memory on 8 January 2007, but the surface unit continued to provide status enabling the system to be recovered the following summer during the JOIS 2007 cruise.

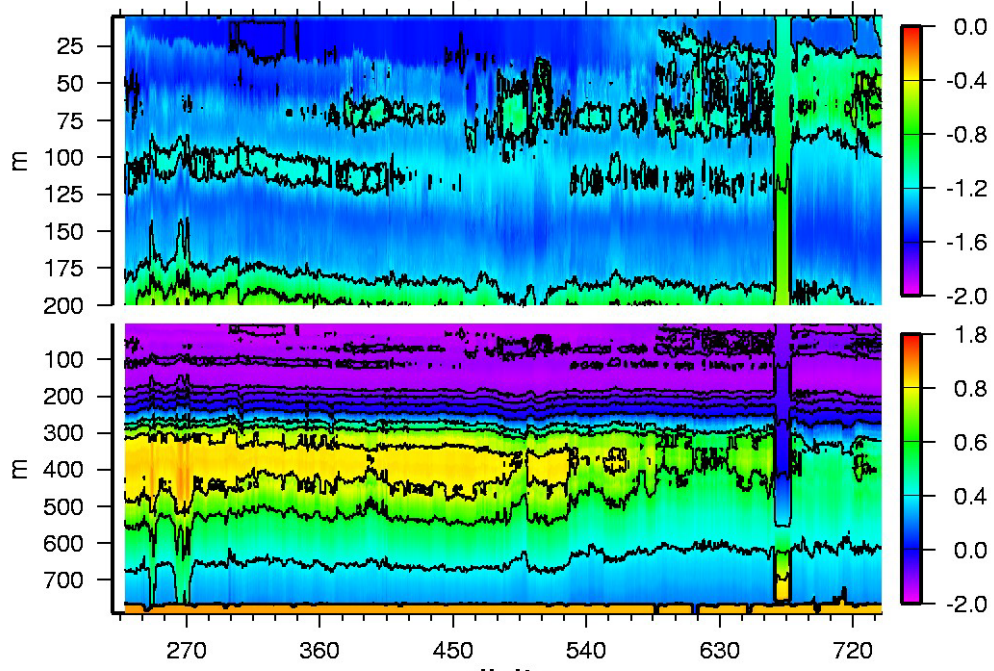
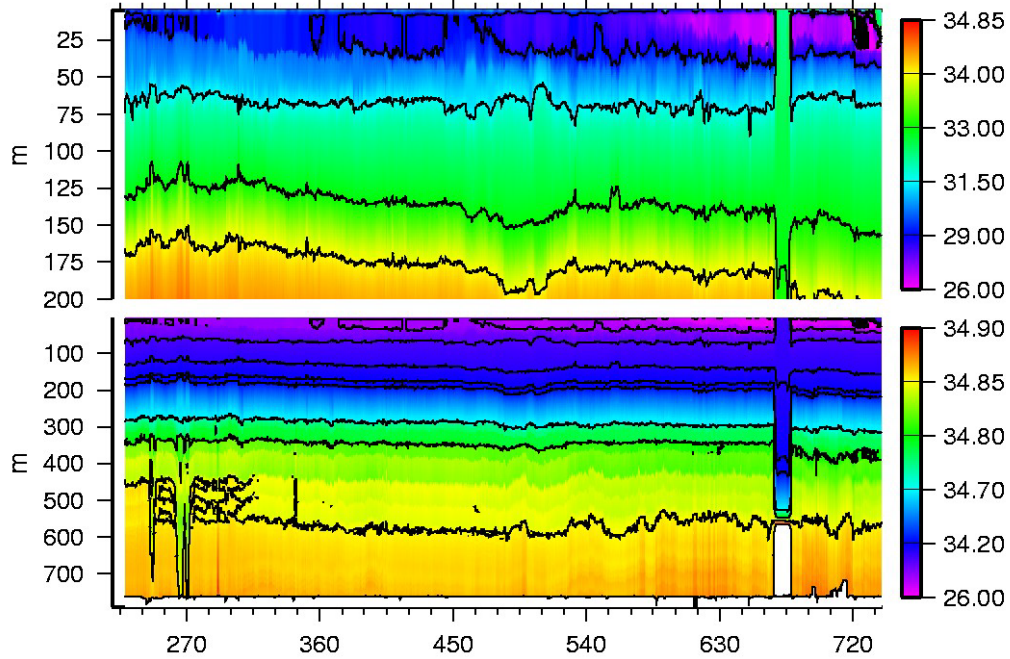
ITP1 Up Profile Contours (to profile 2042)

temperature

salinity

day 2005

ITP 1 Temperature and Salinity contours.

The 2043 profiles that were recovered from the ITP were processed according to the procedures described in the ITP Data Processing Procedures. The processing parameters for ITP1 are shown in the figures to the right. The time series is particularly influenced by a deep eddy(s) between profiles 70-79 and 140-176, which also coincide with shifts in the conductivity calibration ratio. Consistent sensor lags are obtained through the thermohaline staircases except in the eddy and after profile 1257 (when the staircases are not as prevalent). After about profile 1534, the profiler had more frequent difficulties completing full profiles vertically. Some of this could be related to increased ice drifts, by icing, or wire/roller wear could also be factors. No CTD information is available for profiles 1755-1802 when the instrument was stuck at the top, and from profile 1544, as apparently an instrument reset occurred in the underwater unit. Bad points due to suspected biofouling or sensor icing are removed. In the final product, 2037 profiles (99.7%) are free of more than one bad temperature measurements, and 1979 (96.9%) are free of more than one bad conductivity spikes.

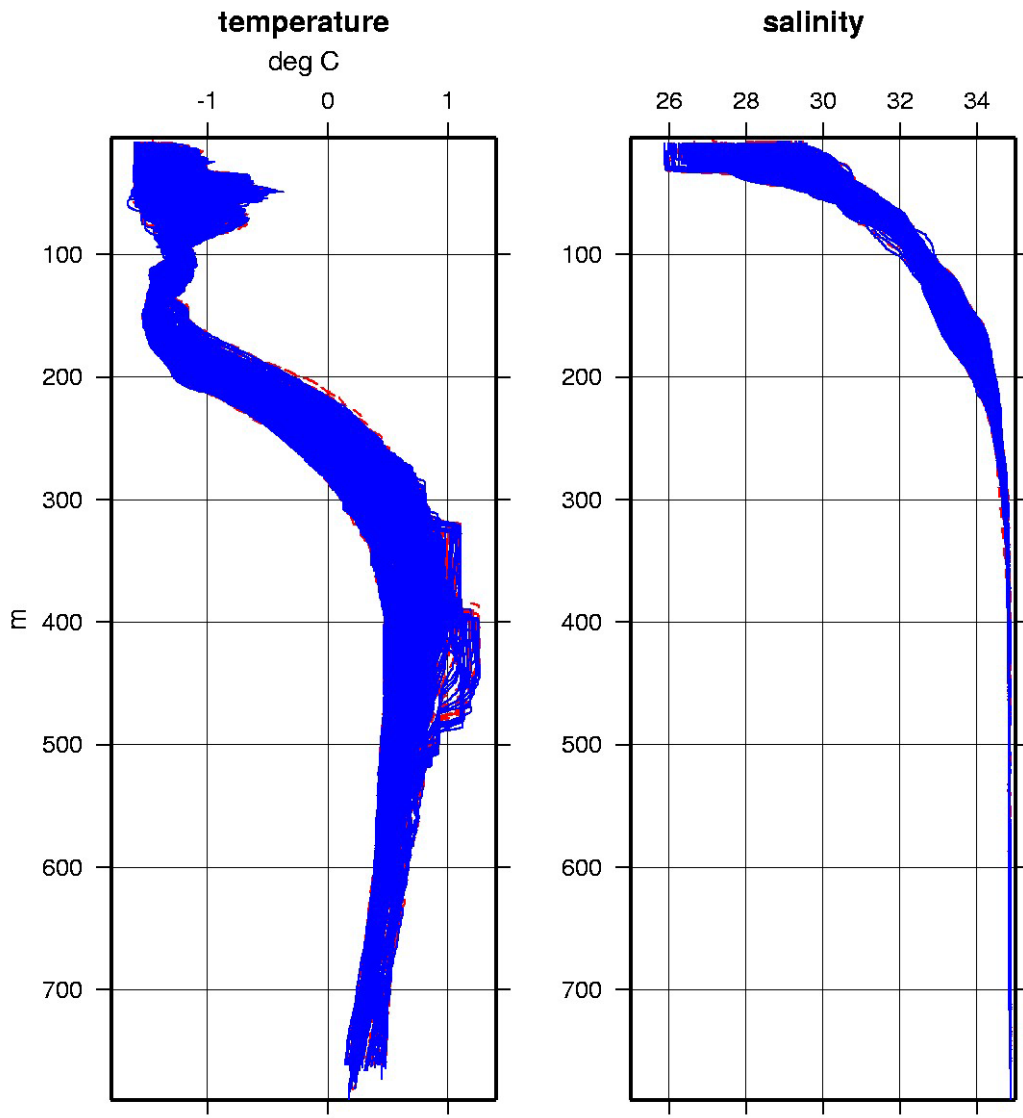
All ITP1 Profiles (up to profile 2042)

up solid, down dashed

Composite plot of ITP temperature and salinity profiles.

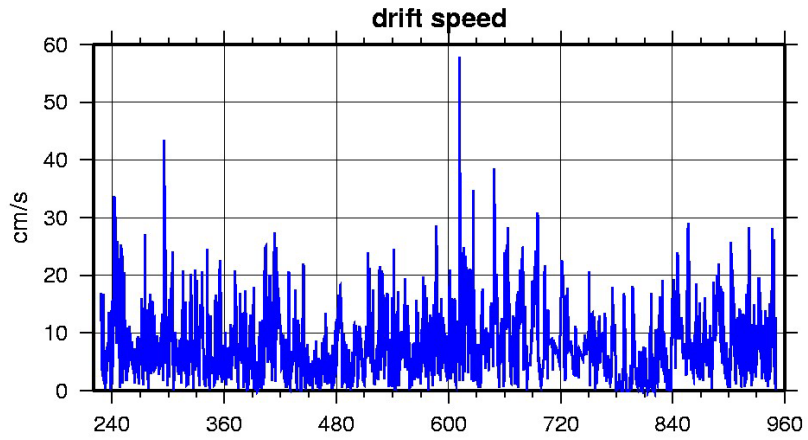
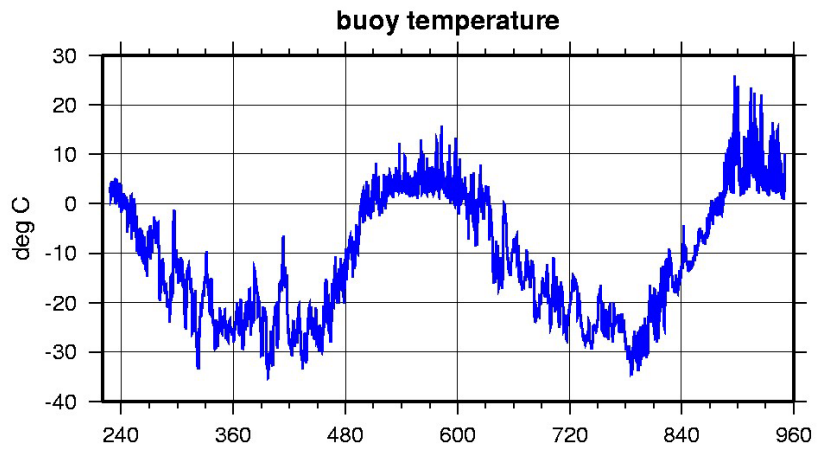
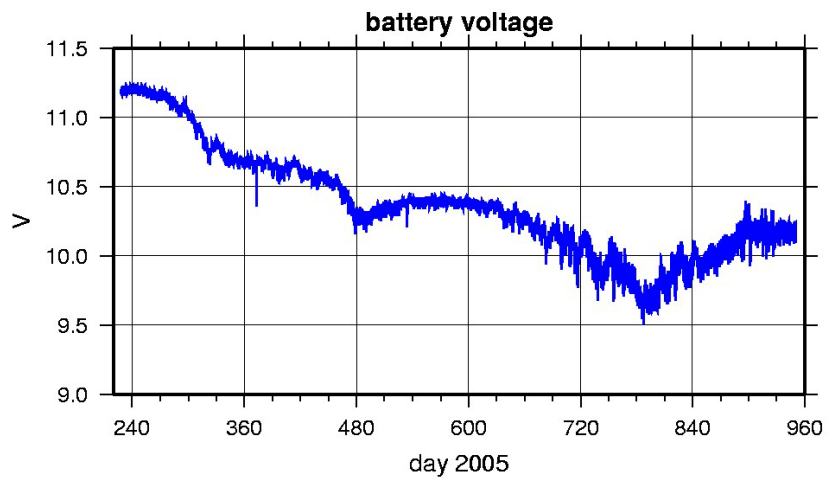
ITP1 Buoy Status (as of 2007/08/08)

ITP surface buoy status

The ITP profiler was configured to operate with an accelerated sampling schedule of 4 one-way profiles between 10 and 750 m depth each day in order to more quickly evaluate endurance and component fatigue and was outfit with an extra battery slice (50% more capacity than standard). In the surface package, the GPS receiver was powered every two hours to obtain locations, and buoy temperature and battery voltage status were recorded. After 511 days of reliable operation and data telemetry, the ITP profiler stopped profiling and acquiring data when the internal flash card memory was filled (the operation software was subsequently rewritten to enable file deletion after successful transferring of data to the surface package to prevent this situation on later profilers). The surface package continued to transmit GPS locations and status for a total of 723 days, when the system was recovered.

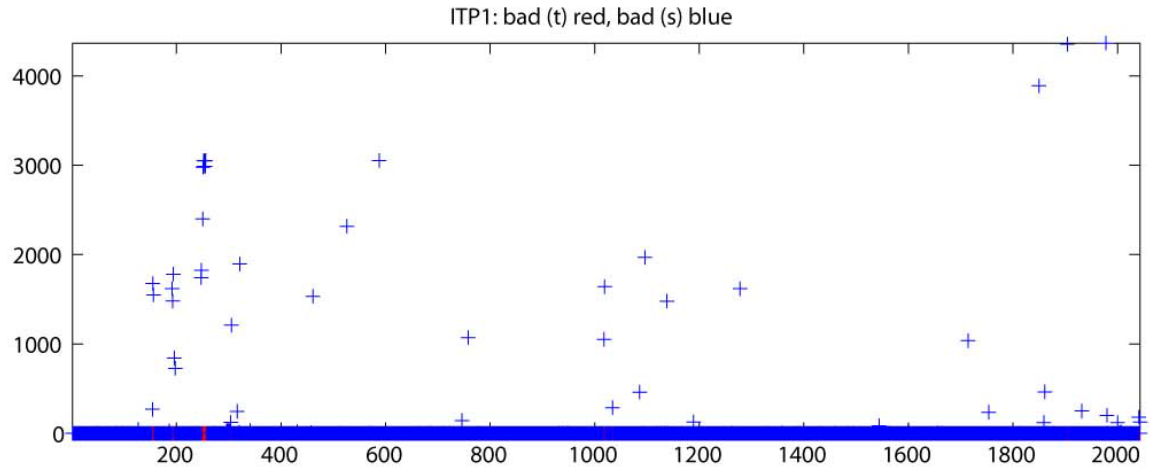
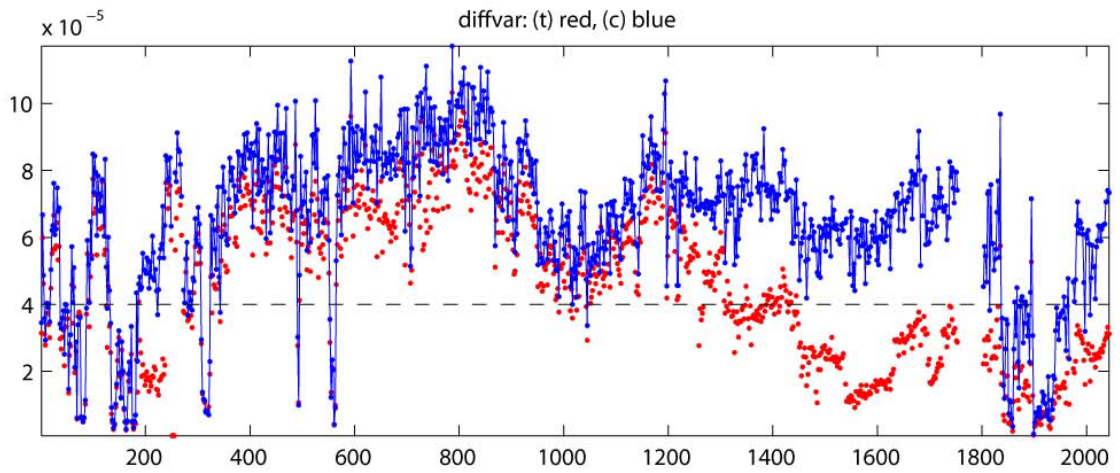
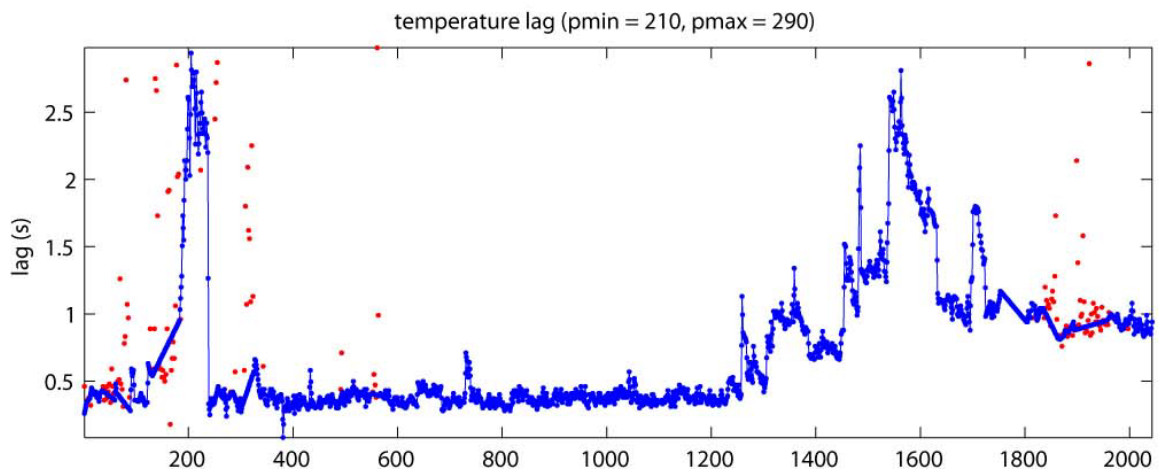
Top: number of bad points removed, Middle: variance of vertical difference of temperature and salinity in step region for up-going profiles, Bottom: temperature lag.

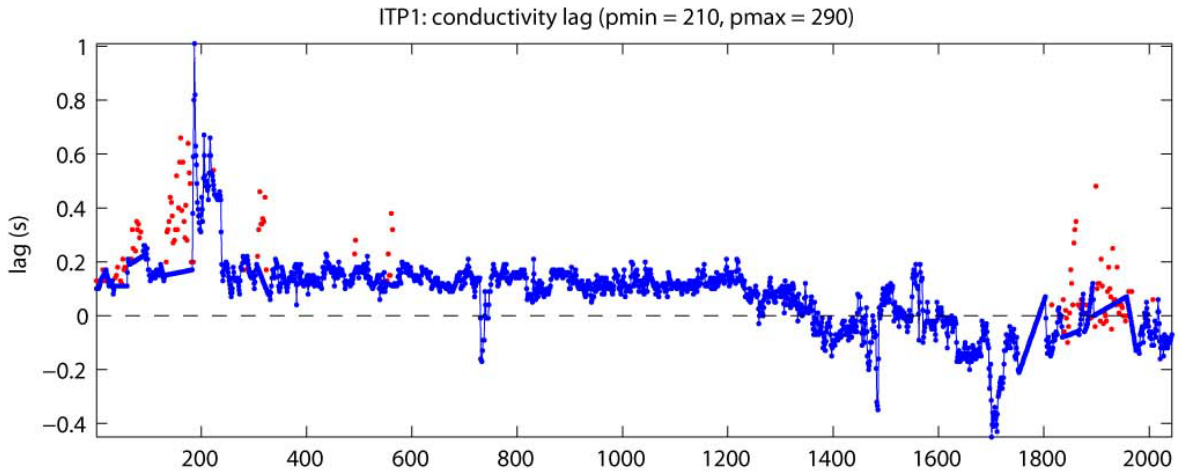
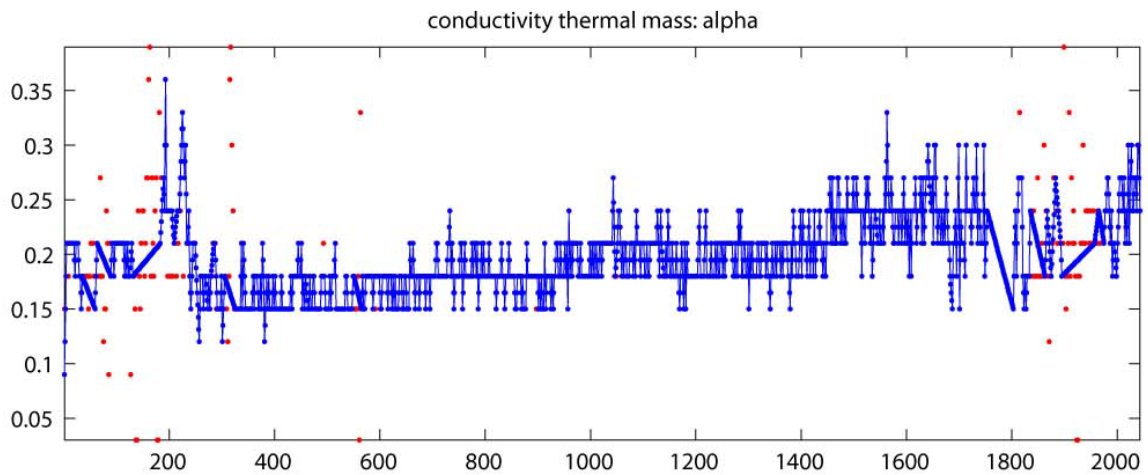
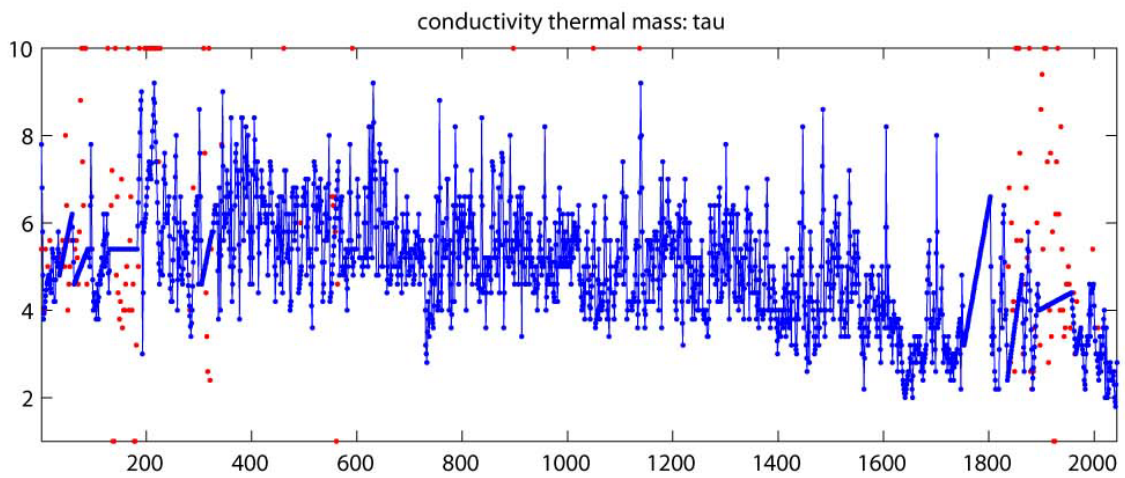
Top: conductivity lag, Middle: conductivity thermal mass amplitude correction, Bottom: conductivity thermal mass lag correction.

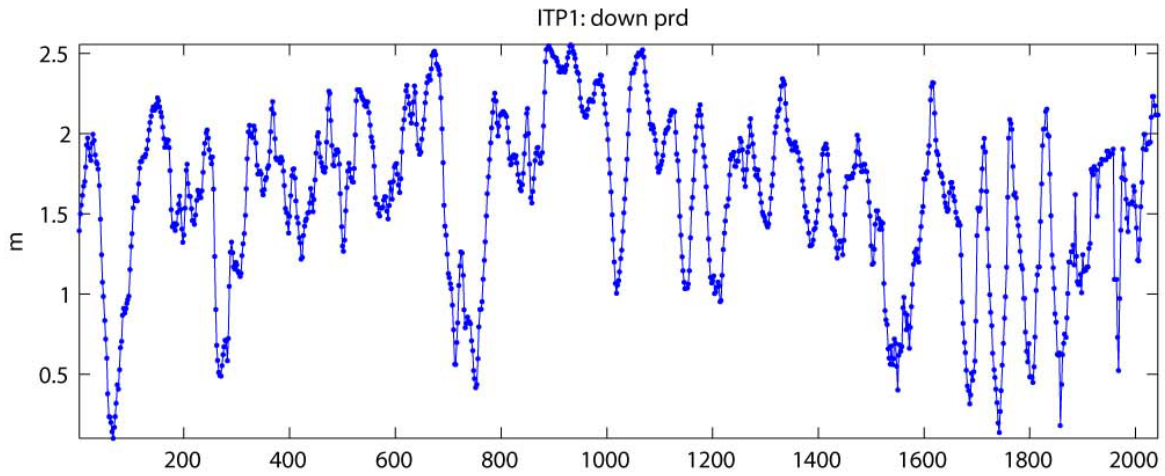
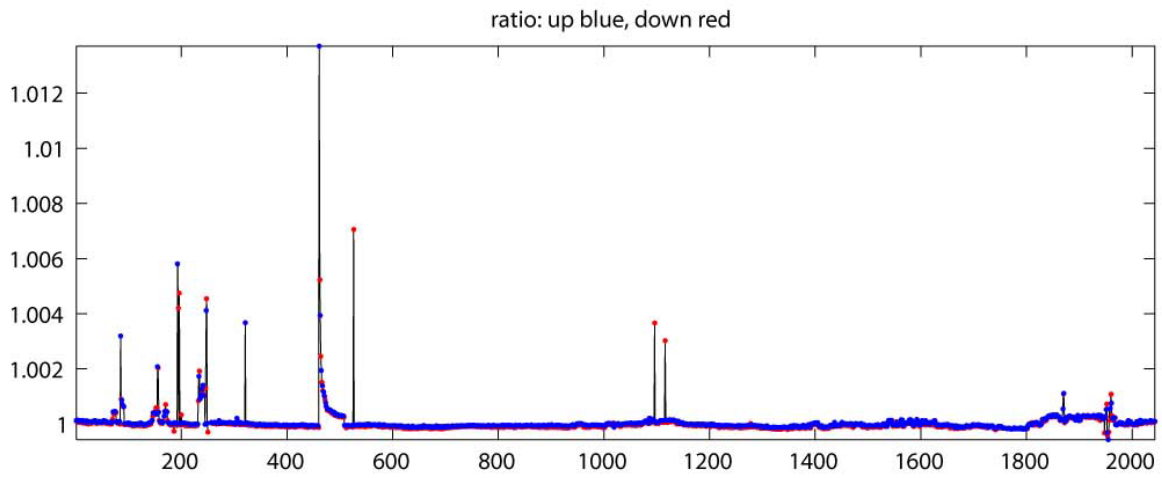
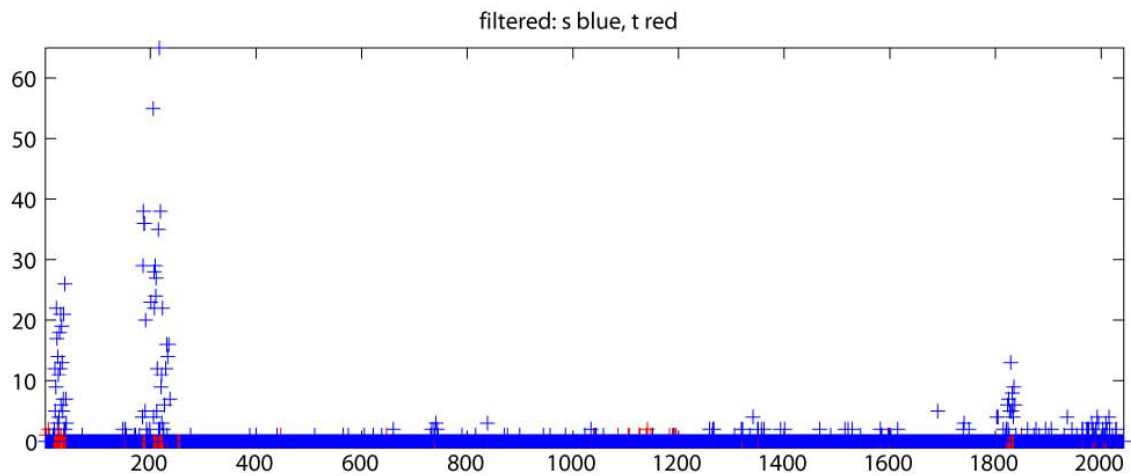
Top: down pressure deviation correction, Middle: salinity ratio adjustment, Bottom: Number of filtered spikes.

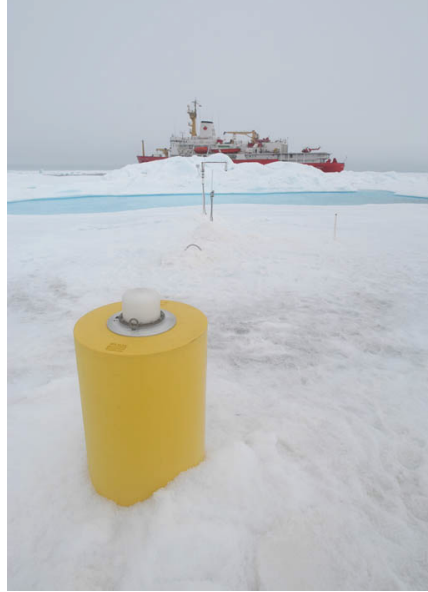
ITP1 and IMB 2005-C as deployed on August 15, 2008, with CCGS Louis St. Laurent in background. Photo by Chris Linder.

By the next morning, the ship was positioned in the lead next to the selected ice floe, where a lone seal was spotted swimming. Between 10:00 and 11:30 MDT (16:00-17:30 UTC), all of the personnel and gear are conveyed to the ice floe in 3 flights and 4 sling loads. While drilling the 10" diameter hole for the ITP we are pleased to find that the ice is much harder than the rotten ice ITP 2 was deployed on last year. The deployment proceeds smoothly and the ITP is completely deployed only 1.5 hours after everything arrived on the ice.

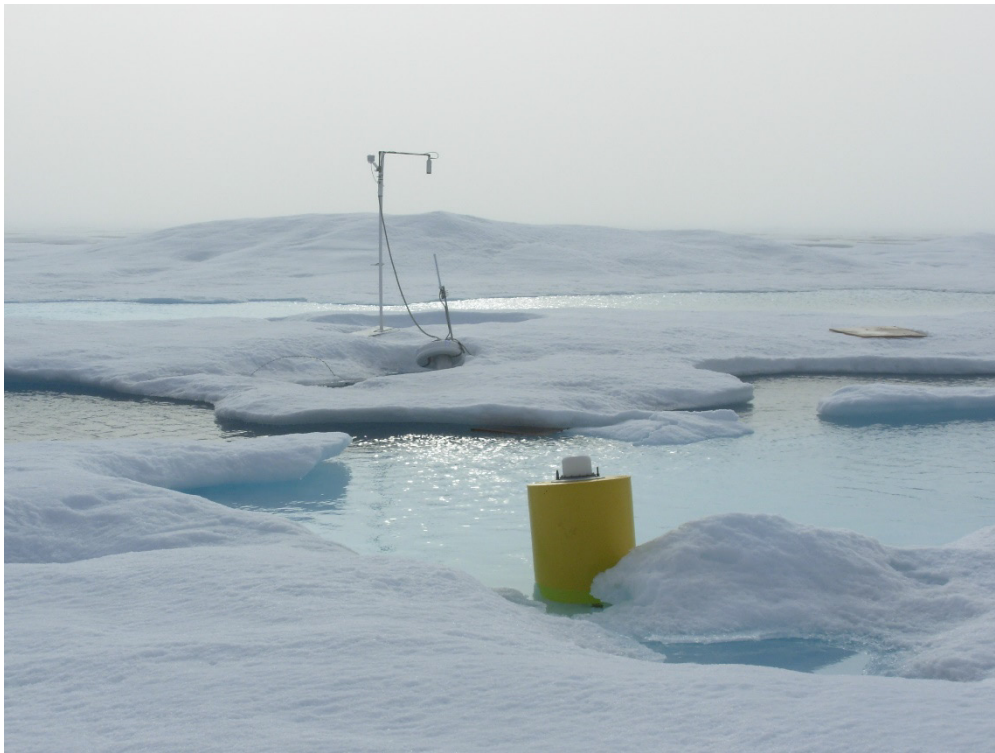
ITP1 and IMB 07949 on August 5, 2008, nearly two years after deployment.

With the ship up against the floe, the recovery operations began with the transfer of personnel and cargo by helicopter from the back deck to the adjacent floe. The floe which contained ITP 1 was still 2.3 m thick, though the ITP surface package itself was located on the edge of a relatively large melt pond about 0.25 m deep. In order to operate all around the buoy, wooden sawhorses and staging were used over the melt pond. First a 30" diameter hot water drill ring was used to cut through the floe, then the ice plug was cleared using a chainsaw (these operations took over 2 hours). The 800 m of wire rope was hauled in using the power-block in a little over an hour, and the ITP profiler removed from the wire. The instrument had light biofouling and a broken spring but was otherwise in good shape.
